NATIONAL TRANSPORTATION SAFETY BOARD

AIRCRAFT ACCIDENT REPORT

In-flight Breakup Over the Atlantic Ocean
Trans World Airlines Flight 800
Boeing 747-131, N93119
Near East Moriches, New York
July 17, 1996

**NTSB/AAR-00/03
DCA96MA070
PB2000-910403
Notation 6788G
Adopted August 23, 2000**

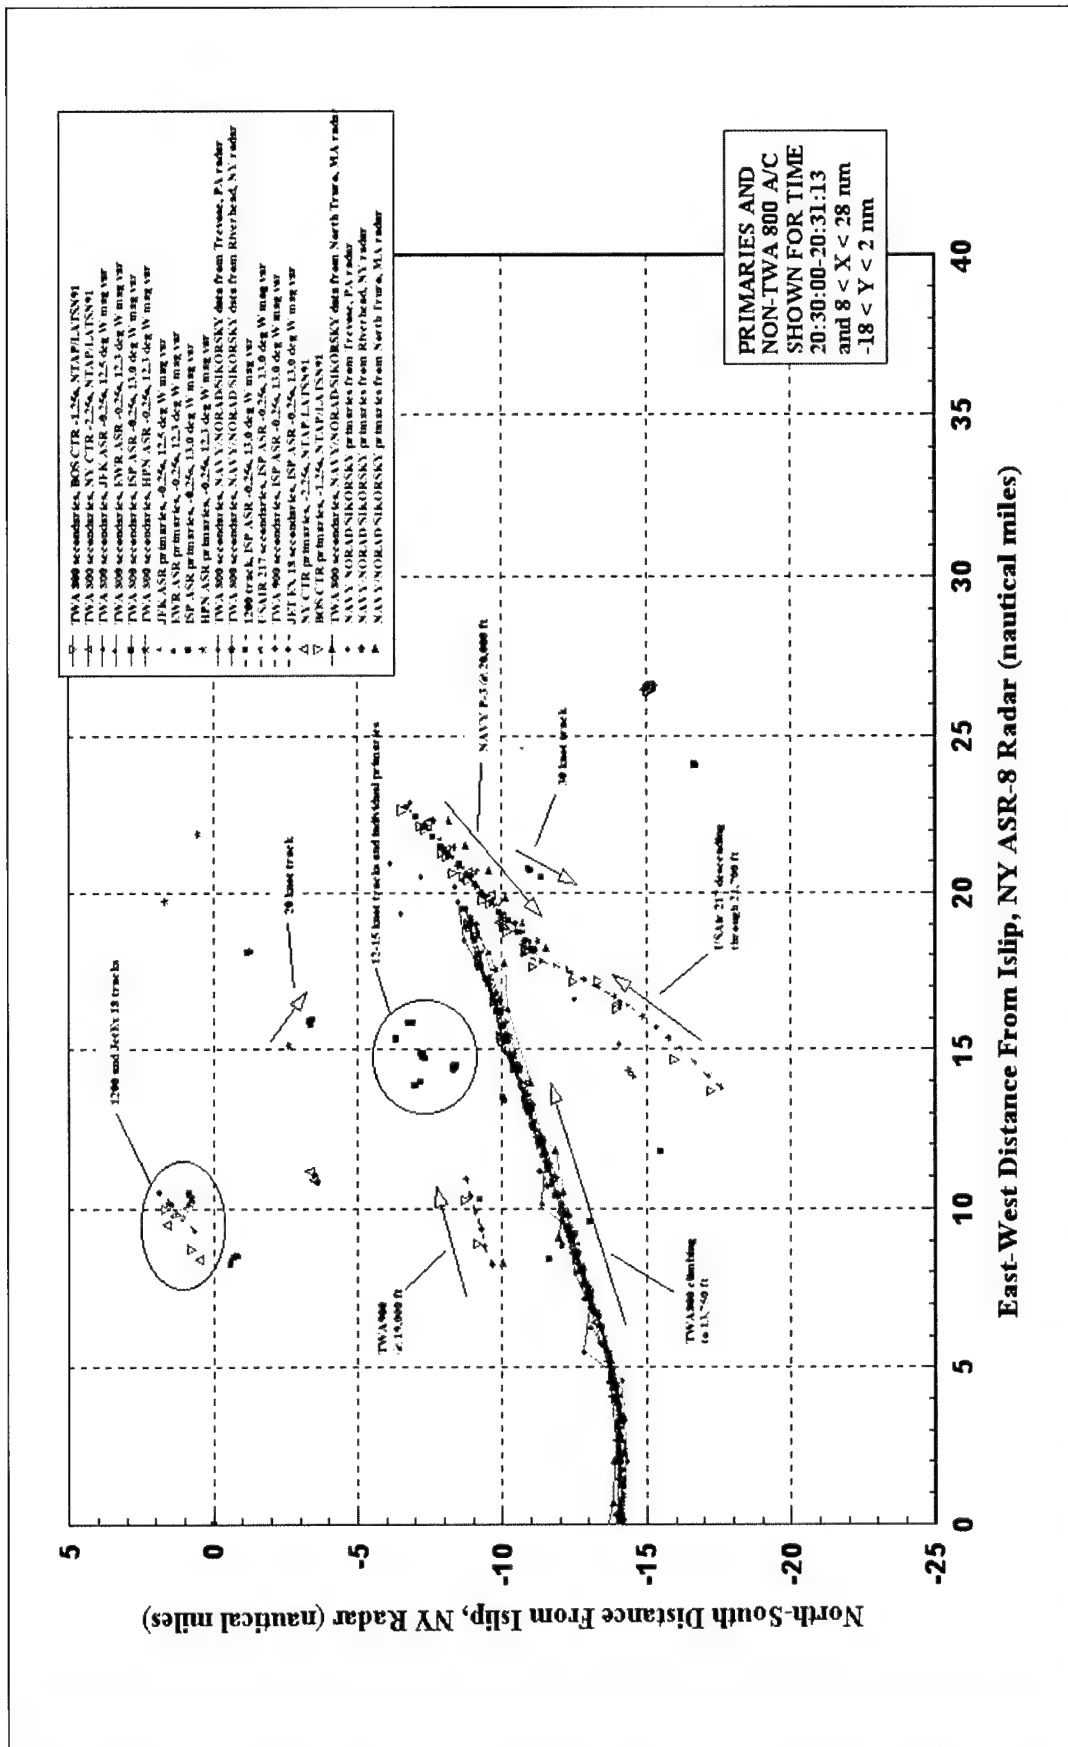
Figure 25. Radar data showing vehicle and/or object tracks within 10 nm of TWA flight 800 just before the accident.

Examination of the radar data showed the following vehicle and/or object tracks within 10 nm of TWA flight 800 just before the accident (see figure 25):

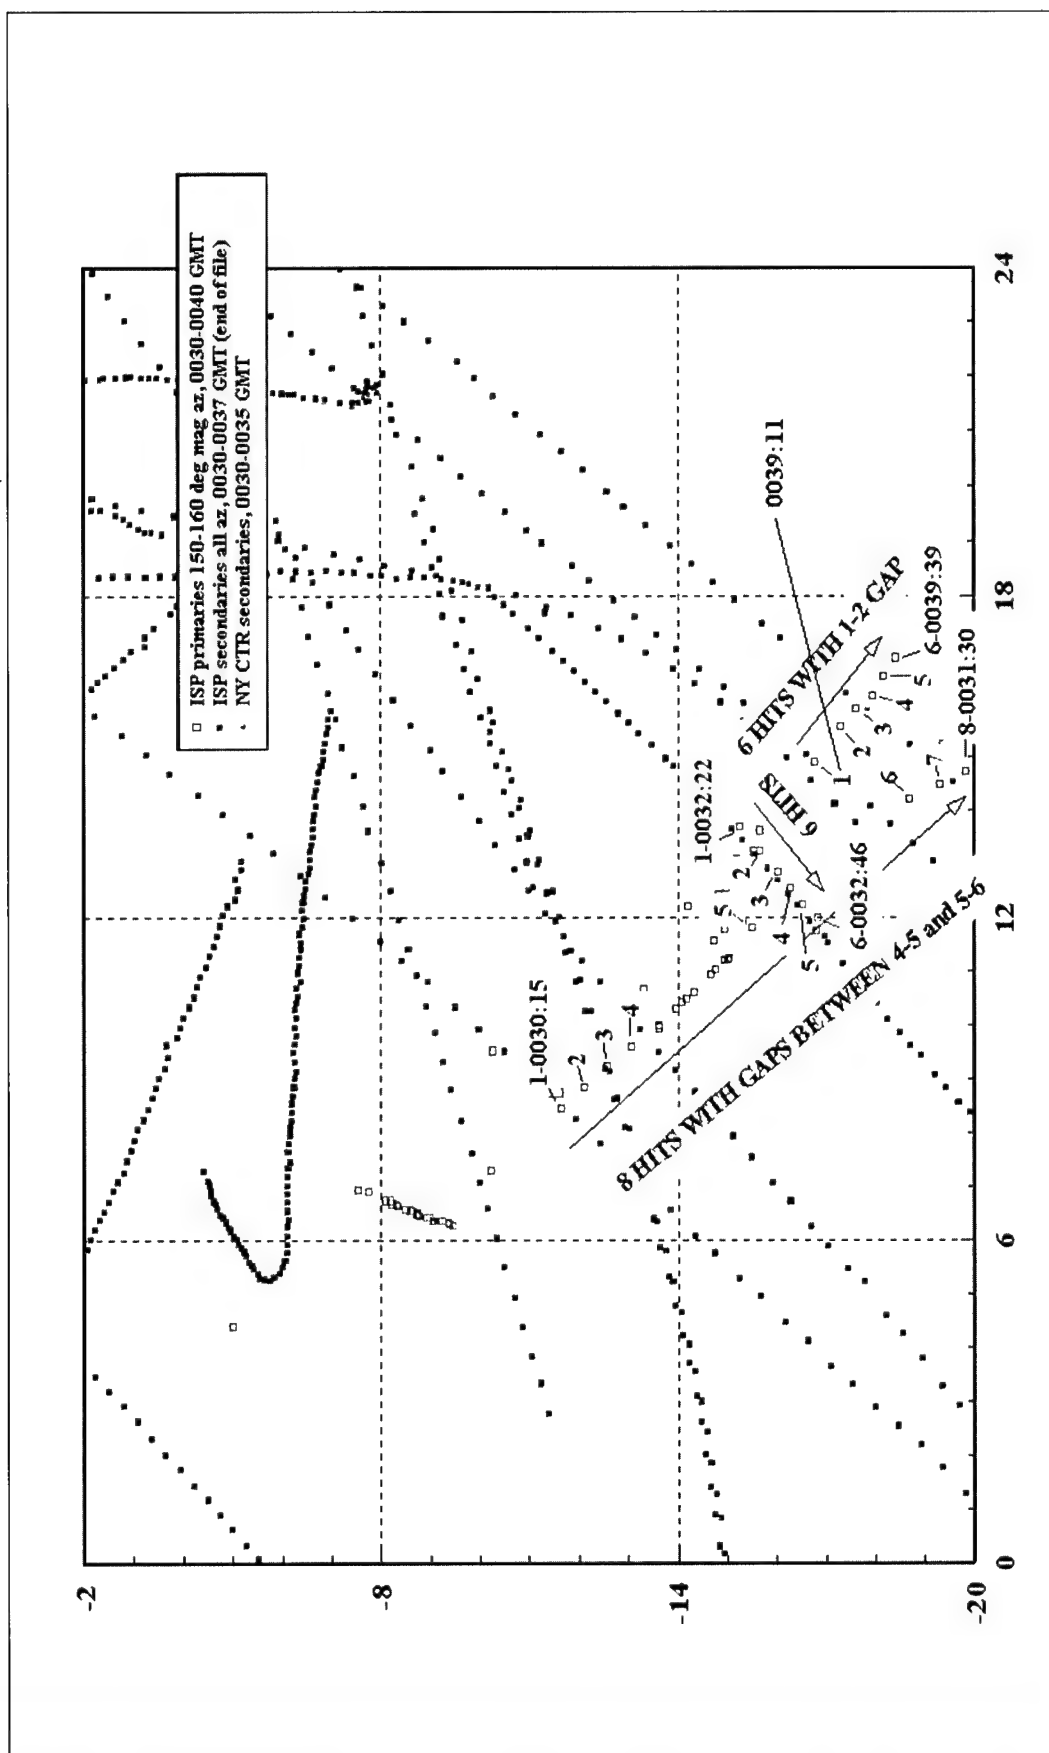
Figure 27. Sequence of eight primary radar returns recorded by the Islip, New York, radar site about the time of the accident.

The Islip, New York, radar data showed one particular sequence of eight primary radar returns about the time of the accident (see figure 27) that warranted further review. On the basis of the times of and distances between these primary radar returns, the target appeared to be moving away from TWA flight 800's position at a ground speed of more than 400 knots. The first of the eight radar returns was recorded at 2030:15, more than 6 nm southeast of the accident airplane. The last of these returns was recorded at 2031:30 (18 seconds after TWA flight 800's last secondary return), about 15 miles southeast of TWA flight 800.

Although most of the radar systems from which the Safety Board obtained data were capable of recording radar targets in the geographic area in which these primary radar returns were recorded, this sequence of eight primary radar returns was only observed in the data from the Islip radar site. Further examination of the returns recorded in that geographic area by the Islip site between about 2030 and 2040 revealed two additional sequences of primary radar tracks with apparent ground speeds greater than 300 knots. One of these sequences indicated a radar target movement away from TWA flight 800 to the southeast, whereas the other sequence indicated a target movement away from TWA flight 800 to the southwest.

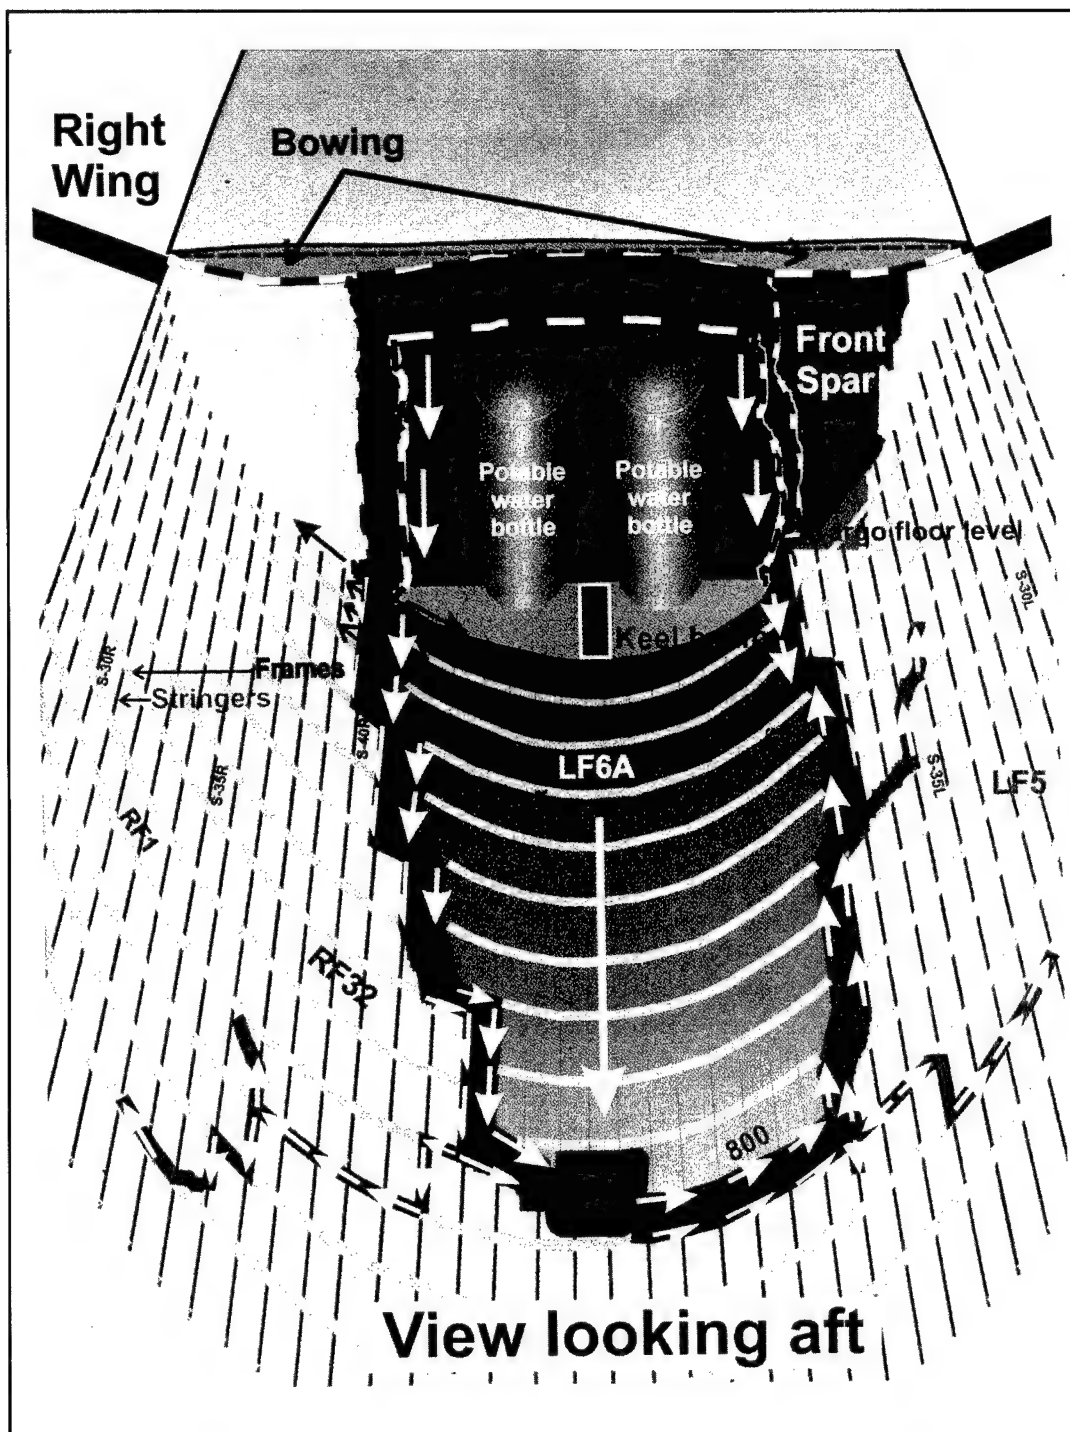
The detailed examinations of the fuselage red zone pieces are an example of how these examinations were successful in determining an important segment of the breakup sequence. Figure 30 shows a schematic drawing of the lower portion of the fuselage skin in the area forward of the front spar. In this figure, the earlier fuselage skin fractures have been highlighted, and arrows have been added to indicate the direction of cracking in these earlier fractures. Of all of the fuselage fractures examined, only a limited number (all of which were on pieces recovered from the red zone) could be classified as earlier fractures (that is, consistent with in-plane loading). Further detailed examination of the rivet-to-rivet fracture pattern in these earlier fuselage fractures generated information on crack propagation directions and indicated that the earliest fracturing was of the lower fuselage, beginning at the front spar of the WCS. (The methodology used to determine the sequence of fracture in the fuselage red zone pieces was typical of the approach used for the entire airplane structure.)

Figure 30. A schematic drawing of the lower portion of the fuselage skin in the area

The Sequencing Group determined that the upper chord of the front spar then completely separated from the WCS upper skin panel, and the overpressure within the CWT forced the WCS lower skin panel and the forward end of the keel beam downward. Stress analysis performed as a part of the sequencing study showed that the continuing downward keel beam motion increased the stresses in the ring chord and fuselage skin adjacent to the front spar. The front spar stiffener at LBL 18 was not bent as far forward as the others, indicating that there was limited forward rotation of the front spar in this area before the ring chord separated at the bottom of the stiffener. Fractures on the right side of the front spar continued into the lower pressure bulkhead,²⁰¹ then continued through the ring chord and into the fuselage skin just in front of the front spar, at stringer 40 right (see figure 30).

On the basis of cracking directions of the fuselage skin, the Sequencing Group determined that the initial fuselage skin cracking (at stringer 40 right just forward of the front spar, about STA 1000) propagated forward and toward the bottom center of the airplane, then continued circumferentially in both directions and back toward the front spar on the lower left side. This fuselage cracking then quickly progressed²⁰² around three sides of a large piece of fuselage belly structure (subsequently identified primarily as piece LF6A). See figure 30 for a diagram of this cracking in the fuselage; piece LF6A is located in the center of this figure.

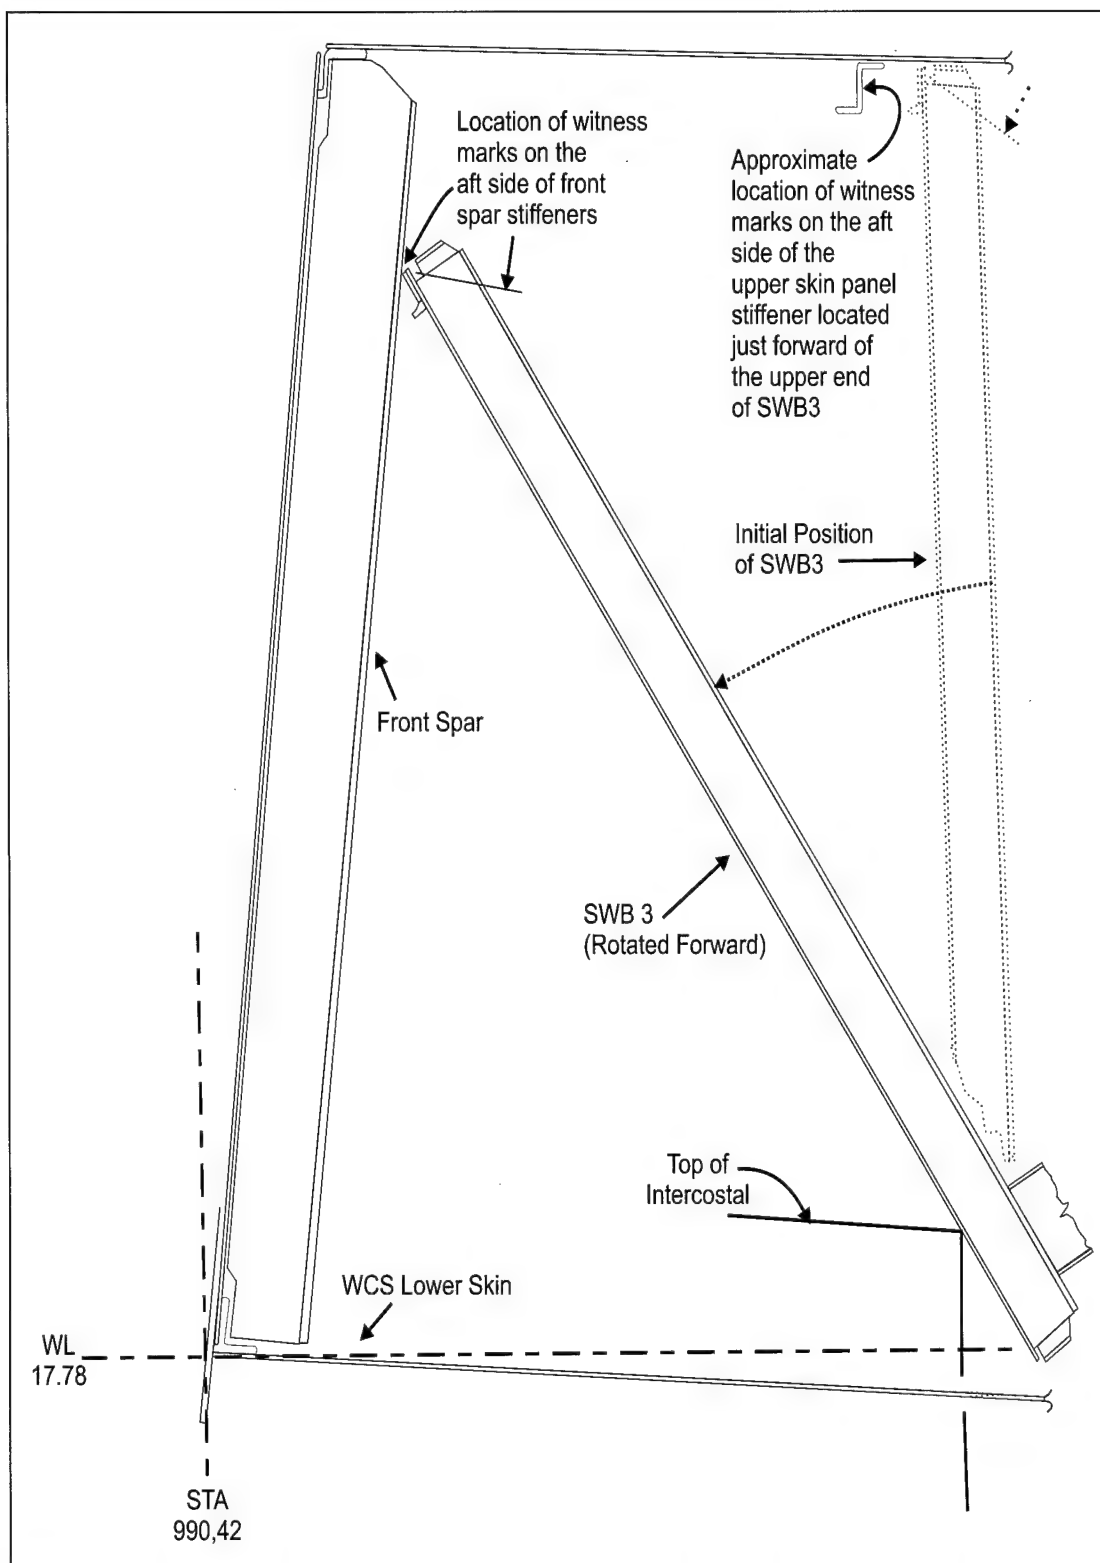
As the upper portion of SWB3 rotated forward, hinging on the still-attached lower chord, the upper chord impacted the aft side of the upper skin panel stiffener immediately forward of SWB3. (Figure 31 shows the approximate shape of this stiffener and its location before being struck by SWB3 as the beam rotated forward.) A geometrical layout of SWB3 and the upper and lower skin panels indicates that the forward rotation of SWB3 about its lower chord would result in an impact on the vertical flange of the stringer about 1.8 inches above the lower edge of the stringer (assuming no relative motion between the upper skin panel and SWB3). However, in the center of this stiffener, a witness mark was

noted at a distance of only 0.9 inch above the lower edge of the stringer. The difference between these values represents an upward vertical displacement of 0.9 inch between the upper and lower skin panels along the airplane's centerline when SWB3 impacted the stringer. The distance of the witness mark from the bottom of the stringer's vertical flange gradually increased at positions further outboard, indicating lesser amounts of upward vertical displacement outboard of the centerline. According to the sequencing study, the location of the marks left on the stiffener by SWB3 indicate that the upper skin of the CWT was likely bowed upward, apparently also as a result of an overpressure event within the CWT.

Figure 31. Diagram showing the approximate shape of the upper skin panel stiffener and its location before being struck by SWB3 as the beam rotated forward.

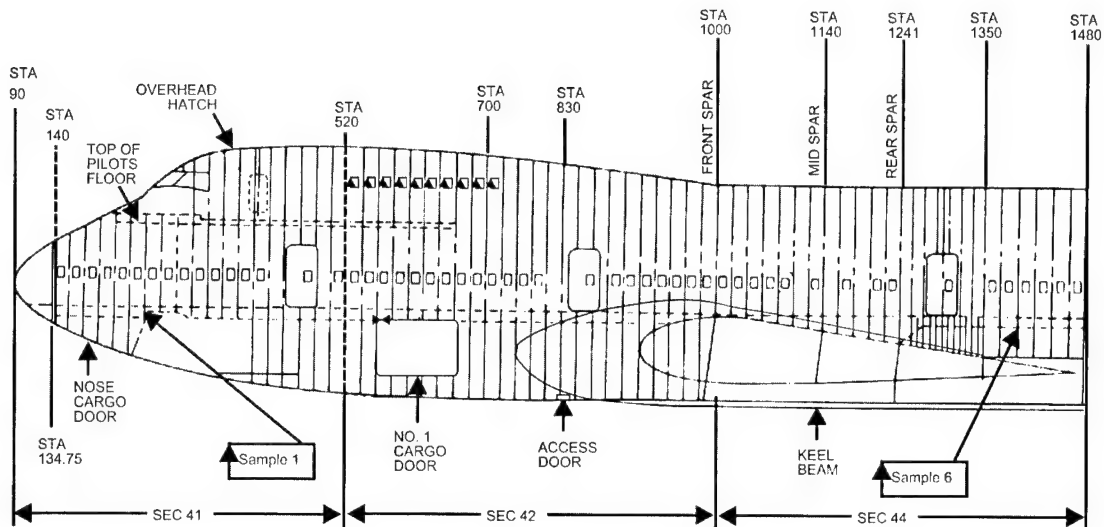
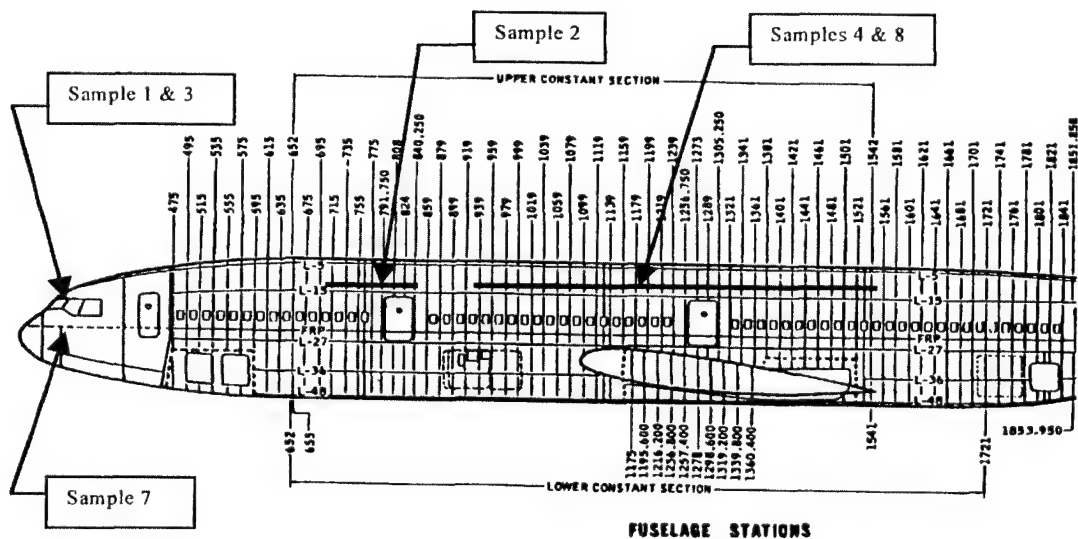
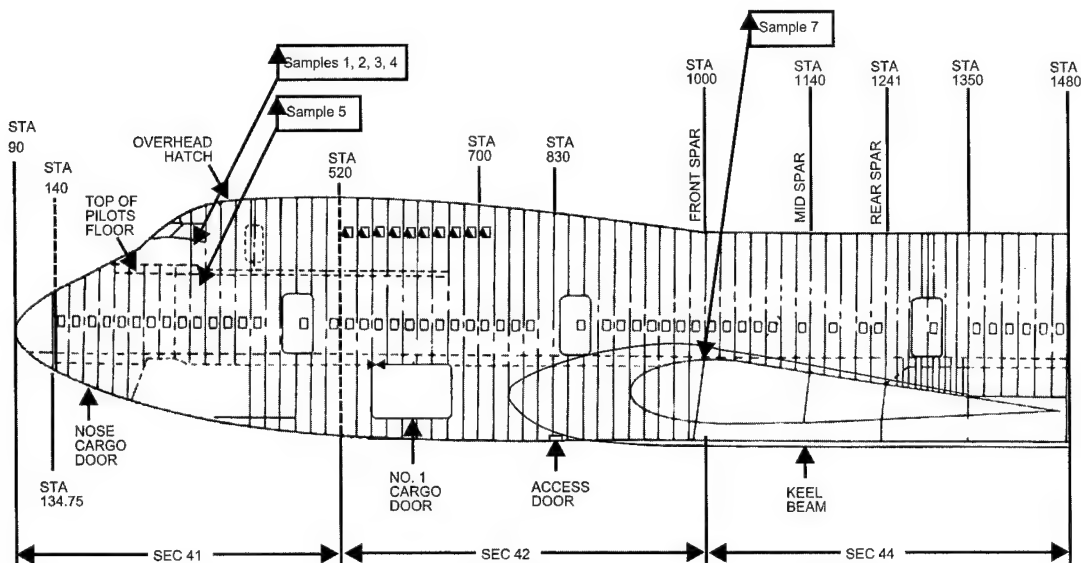
Figure 35a. Sample origination locations for the 747 manufactured in 1970.

Figure 35c. Sample origination locations for the 747 manufactured in 1973.

4. The weak point in this wire type appears to be the lack of ability to maintain physical and electrical integrity during extended elevated thermal exposure with mechanical stress. As the wire ages, there is an increased risk of dielectric problems [breakdown of wire insulation integrity], mechanical damage and loss of electrical integrity.
5. No wire was submitted that was exposed to high levels of environmental exposure (such as wires from wheel wells, wing leading edges, etc.). Wire from these areas, would be expected to perform worse than the wire submitted. [See figures 35a, 35b, and 35c for sample locations.]

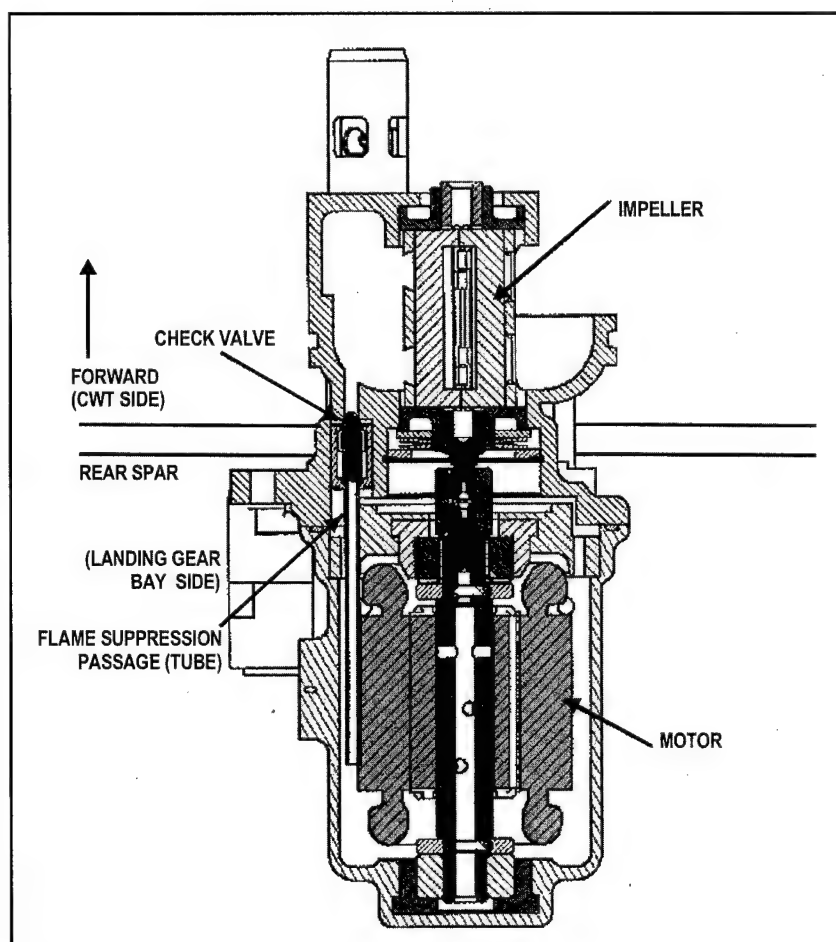
contained multiple explosions that were intentionally ignited within the pump motor cavity, preventing the ignition from transferring to the fuel tank. (Figure 37 is a diagram of a scavenge pump.) Because the Board became aware of instances in which the flame arrestor tube was broken or missing, investigators also conducted a series of tests to determine whether the scavenge pump motor housing would contain explosions with only one of the flame suppression system components (either the flame arrestor tube or the check valve) functioning. In all tests, the scavenge pump housing contained the explosions, and the explosive atmosphere surrounding the test pump did not ignite.

During its postaccident examination of other transport-category airplanes, the Safety Board observed that components in the electrical connector on a scavenge pump in a retired 747 were deteriorated. (Boeing ASBs 747-28A2194 and 747-28A0043, both dated January 18, 1996, "encouraged" operators to inspect for degradation in connectors.) Investigators observed that several scavenge pump electrical connectors had been manufactured of a material that degraded with long-term exposure to fuel. Boeing provided the Board with a service history for the 747 scavenge pump for the 10 years preceding the accident. When queried about the brevity of this history, Boeing indicated that most operators did not return the scavenge pumps to the manufacturer for overhaul.

Figure 37. A diagram of a scavenge pump.

As a result of these findings, Boeing issued ASB 747-28A2206, dated September 25, 1997, and AD 97-25-06, effective December 16, 1997. AD 97-25-06 contained the following summary:

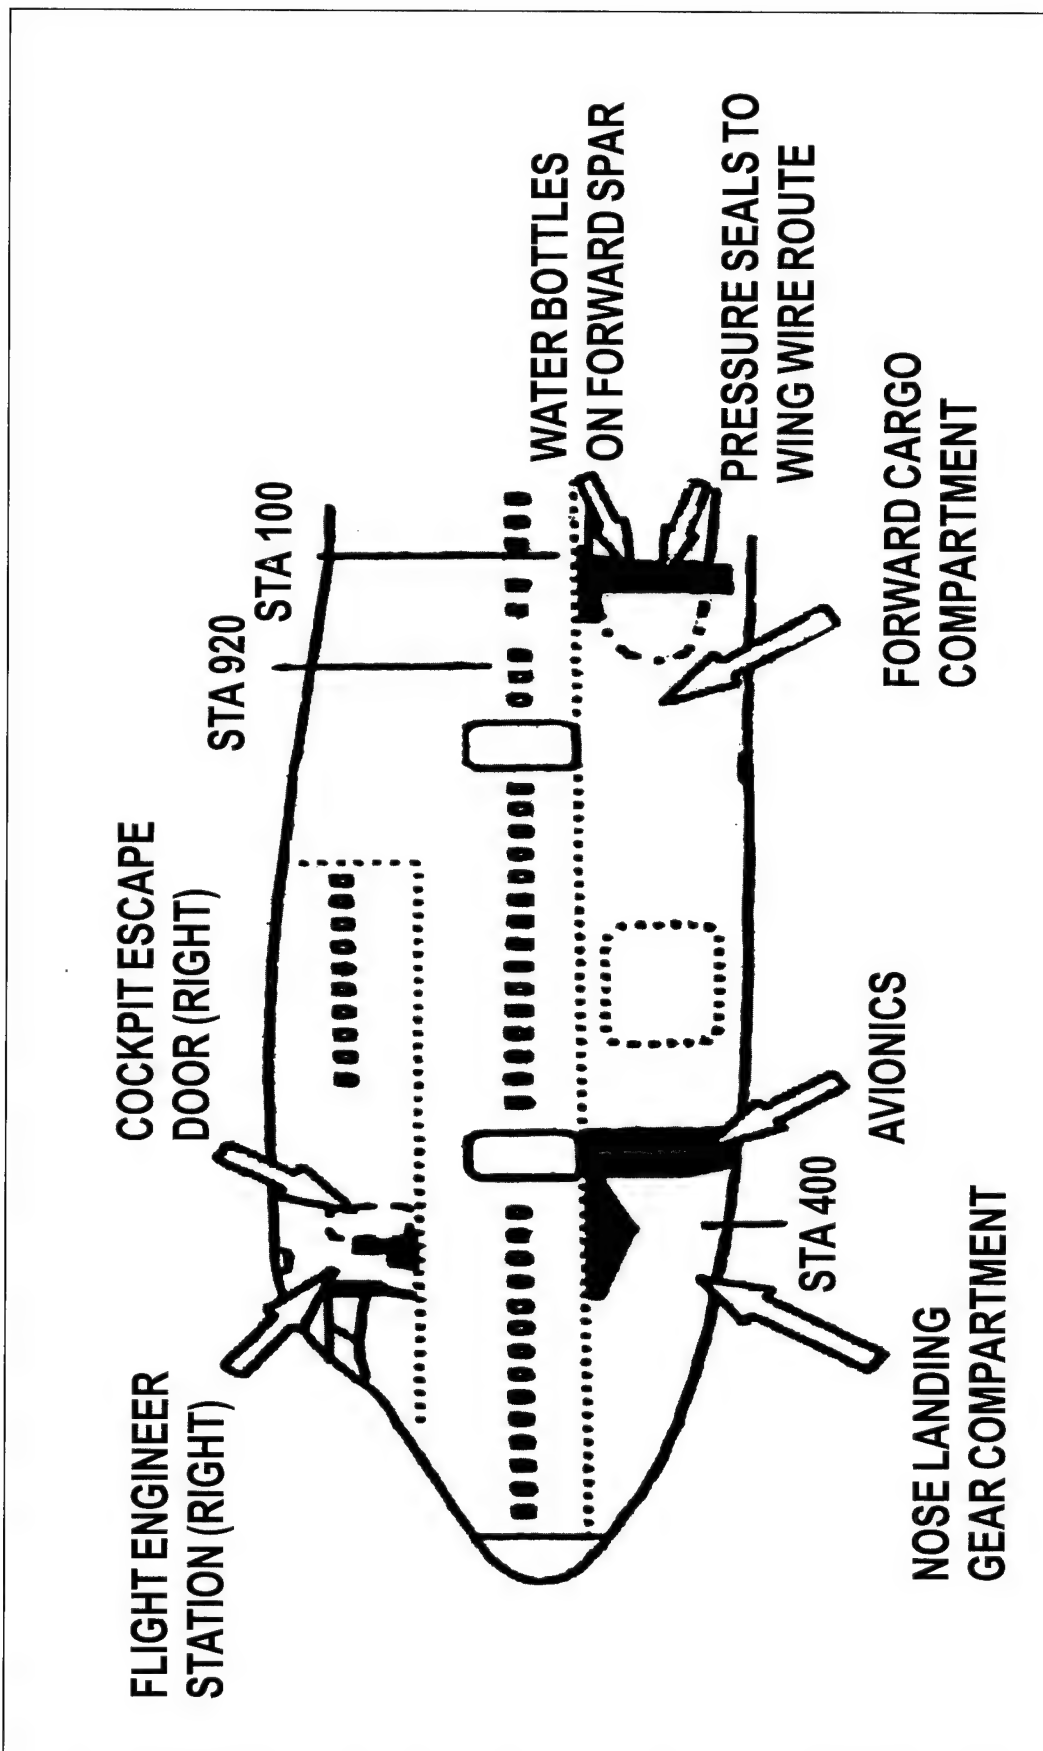
water bottles in the forward cargo compartment, and the pressure seal-to-wing wire route.³⁷⁸ Figure 38 shows the areas typically inspected on 747 airplanes.

Figure 38. Diagram showing the areas typically inspected on 747 airplanes.

In one airplane (its last known flight was in January 1997), wires in the raceway over the CWT were not bundled (as indicated by Boeing's PIs) but were randomly laid in a tray, such that individual wires crossed from one side of the tray to the other. Higher-voltage generator and galley power cables were clamped to the adjacent structure (not routed in the tray). Inspection of the inside of this airplane's CWT revealed the following: the scavenge pump inlet screen contained a nearly 1-inch-long uninsulated wire fragment, a vertically routed FQIS wire was chafed where it contacted a horizontal structural flange, and a horizontally routed FQIS wire was chafed where it contacted a vertical row of rivets between two supporting clamps. Examination of this airplane's CWT fuel quantity probes by the AFRL experts revealed sulfide deposits on the bare wire ends and terminal sleeves, and some of the wires were loose under the clamps; two of the wires exhibited striation marks that resembled jaw marks of a wire stripping tool.

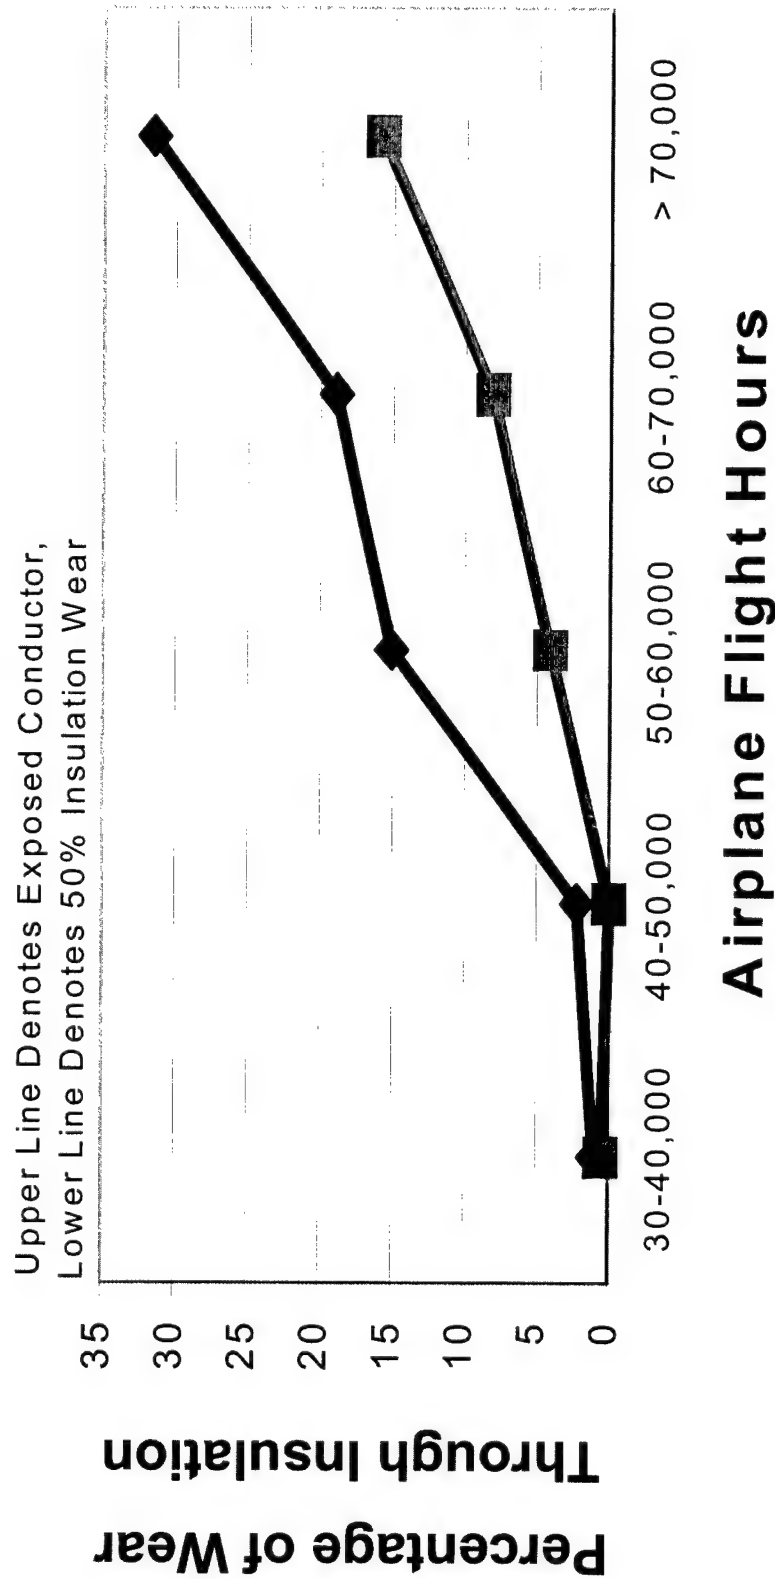
conduits, on May 10, 1998; (2) AD 98-11-52, which revised the flight-hour requirement outlined in AD T98-11-51 to include airplanes with more than 40,000 flight hours, on June 24, 1998; and (3) AD 99-21-15, which further revised the flight-hour requirement outlined in AD T98-11-51 to include airplanes with more than 20,000 flight hours, on October 8, 1999. Figure 39 shows the 737 fuel pump conduit wear rate that was identified by the FAA during representative 500 wire inspections.⁴¹² Similar data for 747 inspection results were not released.

Figure 39. A chart showing the 737 fuel pump conduit wear rate that was identified by the FAA during representative 500 wire inspections.

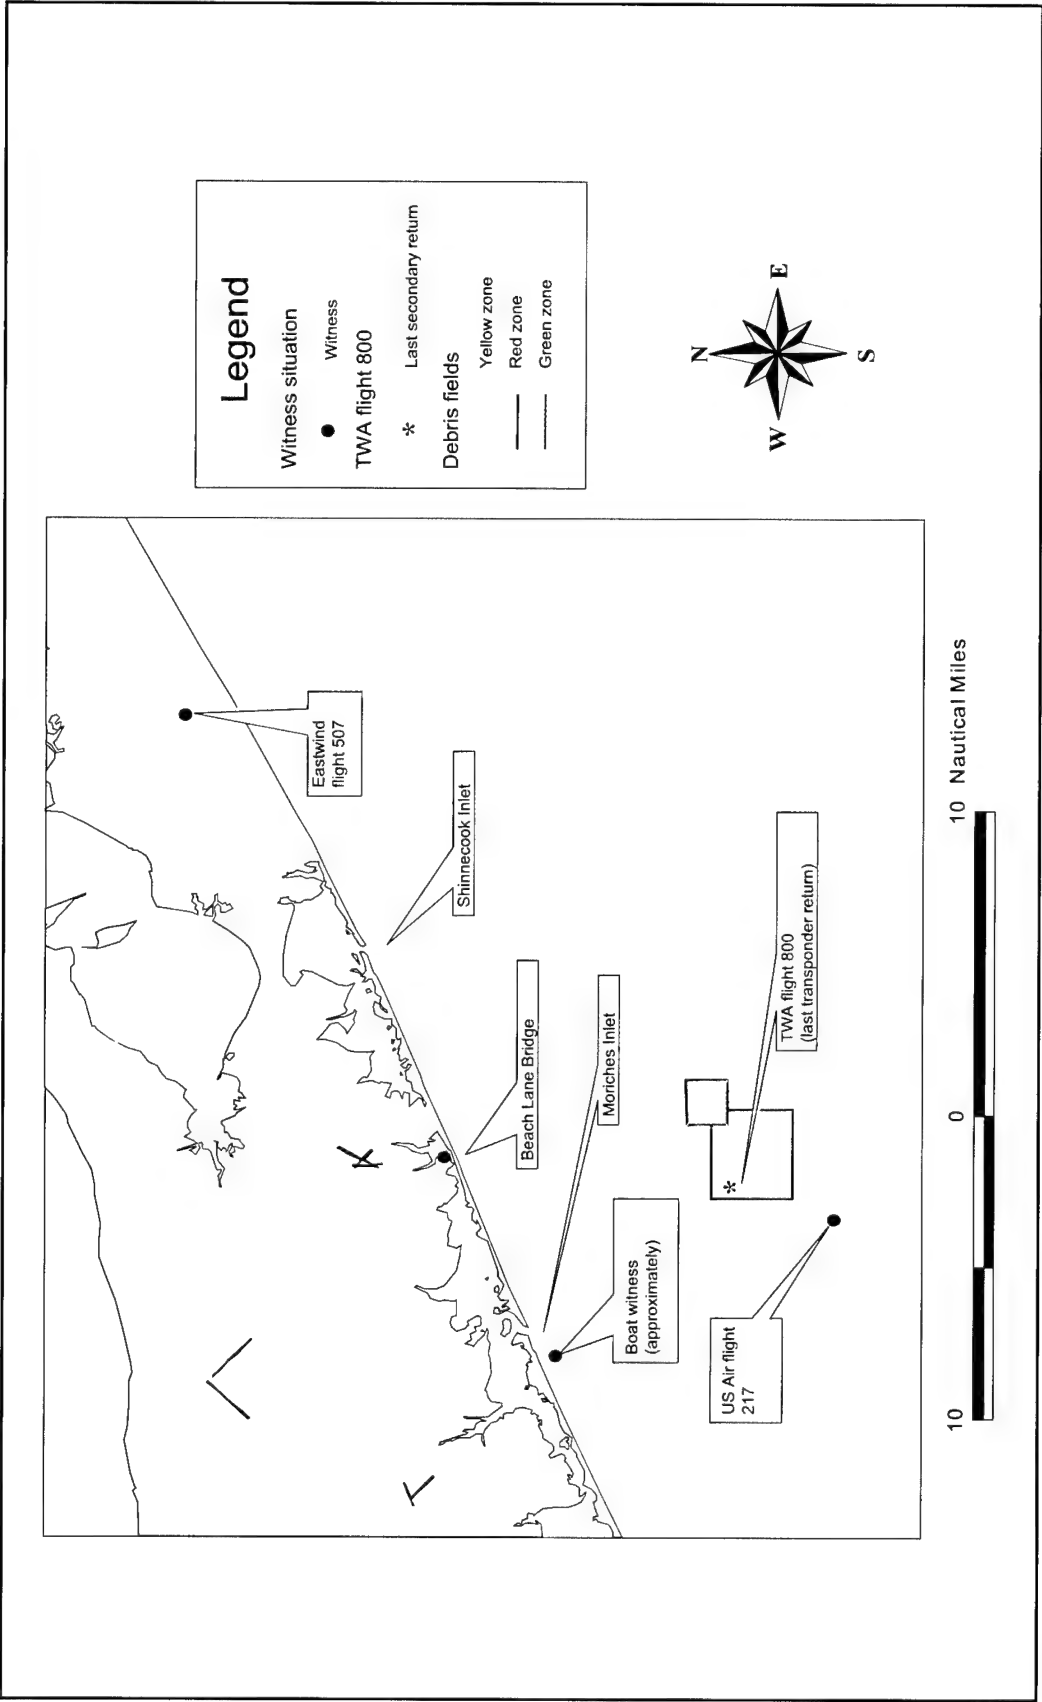
Figure 41. A map showing the debris zones and the positions of the five witnesses of special interest.

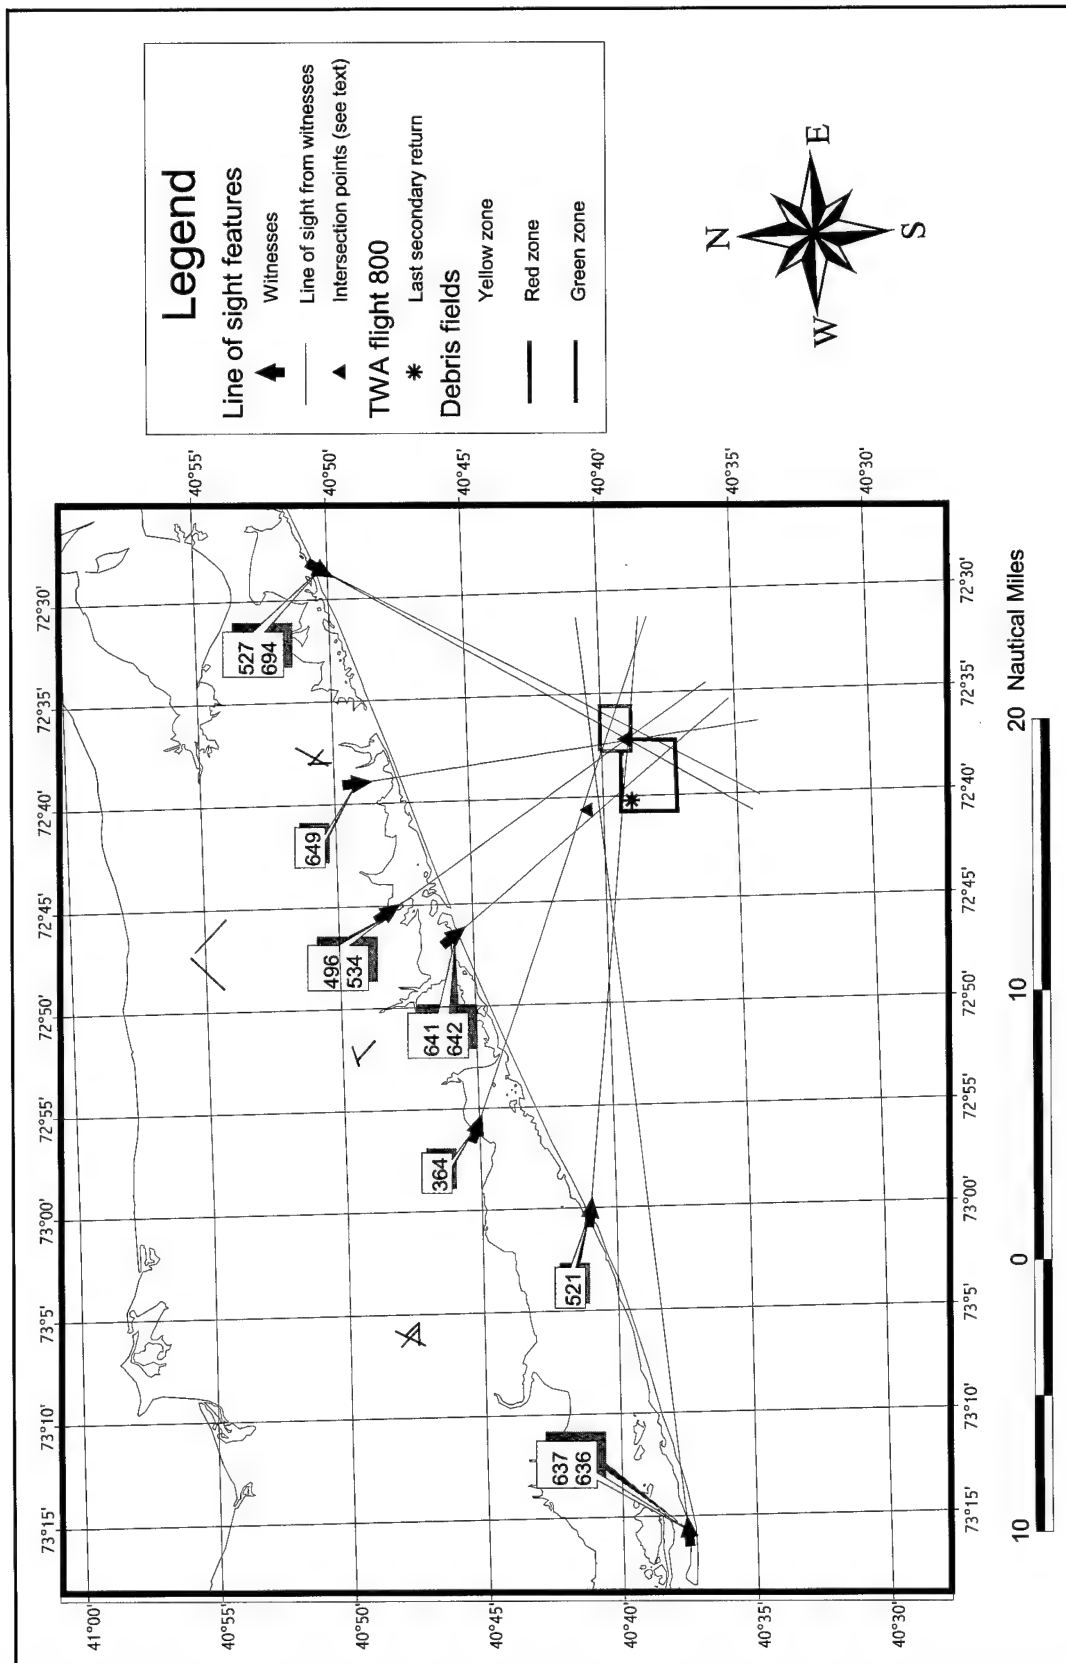
Figure 42. Map of sight lines plotted for 11 witnesses.

⁵⁶⁰ This is consistent with the results of the FBI-sponsored line-of-sight study in which a Deputy Inspector from the Suffolk County Marine Bureau drew a line of sight from the location of 11 witnesses through a fixed reference point where they each reported having seen a streak of light. (See figure 42.) The sight lines for 7 of the 11 witnesses studied intersected the green zone (and two passed just north of it), where the main portion of the wreckage was recovered from the ocean. These sight lines are consistent with these witnesses observing only the last portion of crippled flight.

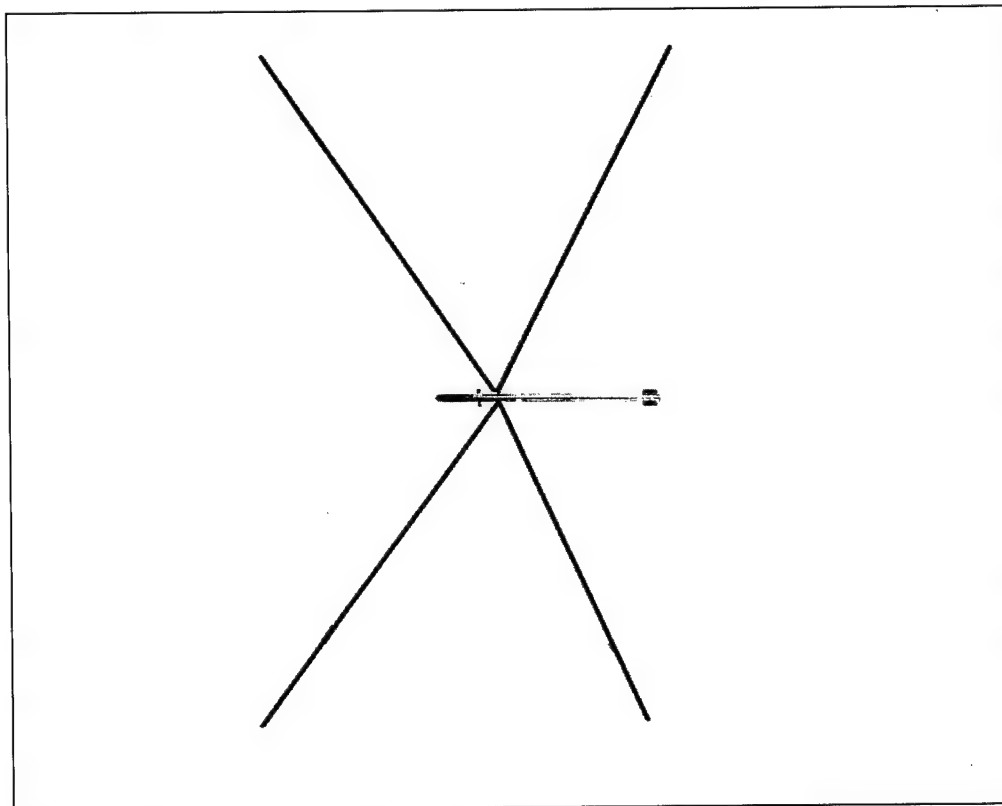
According to the MSIC, warhead detonation typically results in about 1,000 fragments of various sizes, with an average mass of less than 10 grains (0.0229 ounce), and a mass as large as 40 grains (0.0916 ounce) in the pattern shown in figure 43. MSIC reported that warhead fragments could have an initial velocity of up to 9,000 fps. Data obtained from the SURVIAC indicated that 10- and 40-grain fragments would require velocities of 3,500 fps and 2,000 fps, respectively, to penetrate the CWT if they impacted the bottom of the CWT at a right angle. Using the initial speed and speed decay rate for the warhead fragments, the Safety Board calculated that a detonation would have to occur 40 feet or less below the airplane's CWT for a fragment to retain sufficient velocity to penetrate the CWT.

Figure 43. Diagram of warhead detonation fragment pattern.

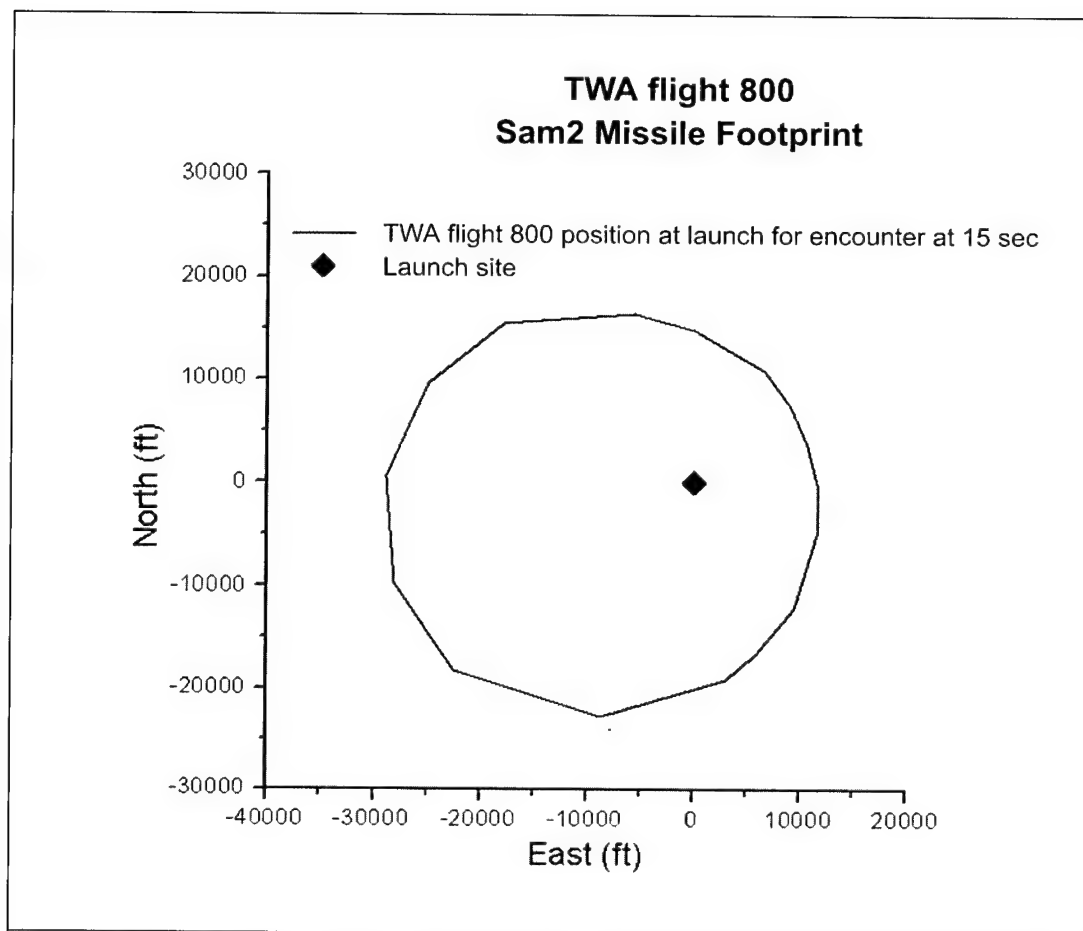
The Safety Board's computer simulations (using this missile performance data and taking into account the winds at the time of the accident) showed that the locations on the surface from which a missile launched at TWA flight 800 would result in selfdestruction within 40 feet of the airplane were extremely limited. Figure 44 shows airplane locations at which, if a high-performance missile were launched at the airplane, the missile would selfdestruct within 40 feet of the airplane. Note that, at the scale shown, the launch area that would result in a selfdestruction within 40 feet of the airplane is not as wide as the line showing the 15-second perimeter in this figure.

Figure 44. Diagram showing airplane and missile launch site locations that could result in missile selfdestruct within 40 feet of the plane.

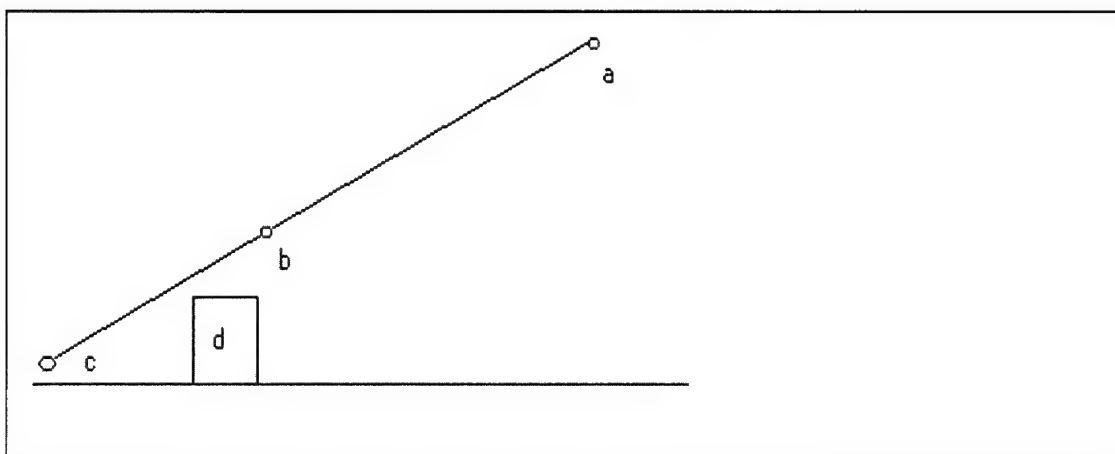
It should also be noted that witnesses observing the accident from Long Island would have been viewing it against a featureless background and, therefore, would have had few, if any, depth perception cues. Consequently, because of the tendency to perceive more distant objects as being about the same distance away as intervening objects (the equidistance tendency), the streak of light could have appeared closer to them than it actually was. The equidistance tendency is illustrated in figure 45, which depicts a person at point “c” observing an object at point “a” that appears at point “b” at the same perceptual distance as an intervening building at point “d.”

Figure 45. A graphical illustration of the equidistance tendency.
